## THE EFFECT OF HIGHER MODES ON EARTHQUAKE FATIGUE DAMAGE TO STEEL MOMENT FRAMES

A Dissertation Presented to the FACULTY OF THE GRADUATE SCHOOL UNIVERSITY OF SOUTHERN CALIFORNIA In Partial Fulfillment of the Requirements for the Degree DOCTOR OF PHILOSOPHY (CIVIL ENGINEERING)

May 2008

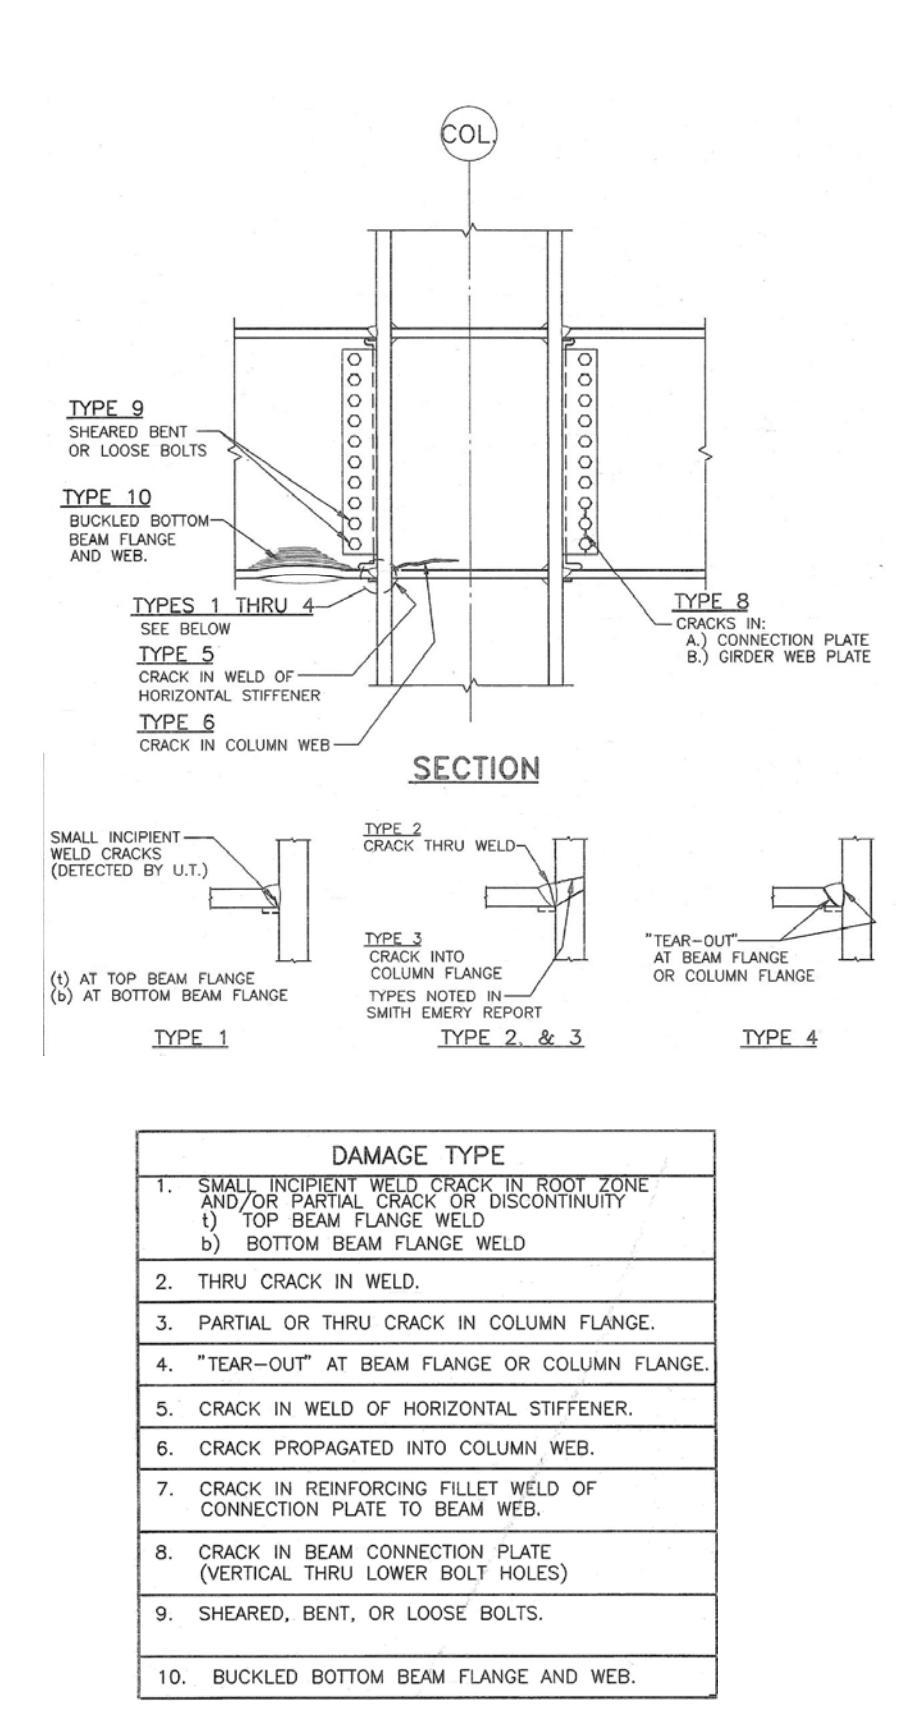
Figure 3.6: Typical moment frame connection damage. [Brandow and Johnston, Inc. drawings]

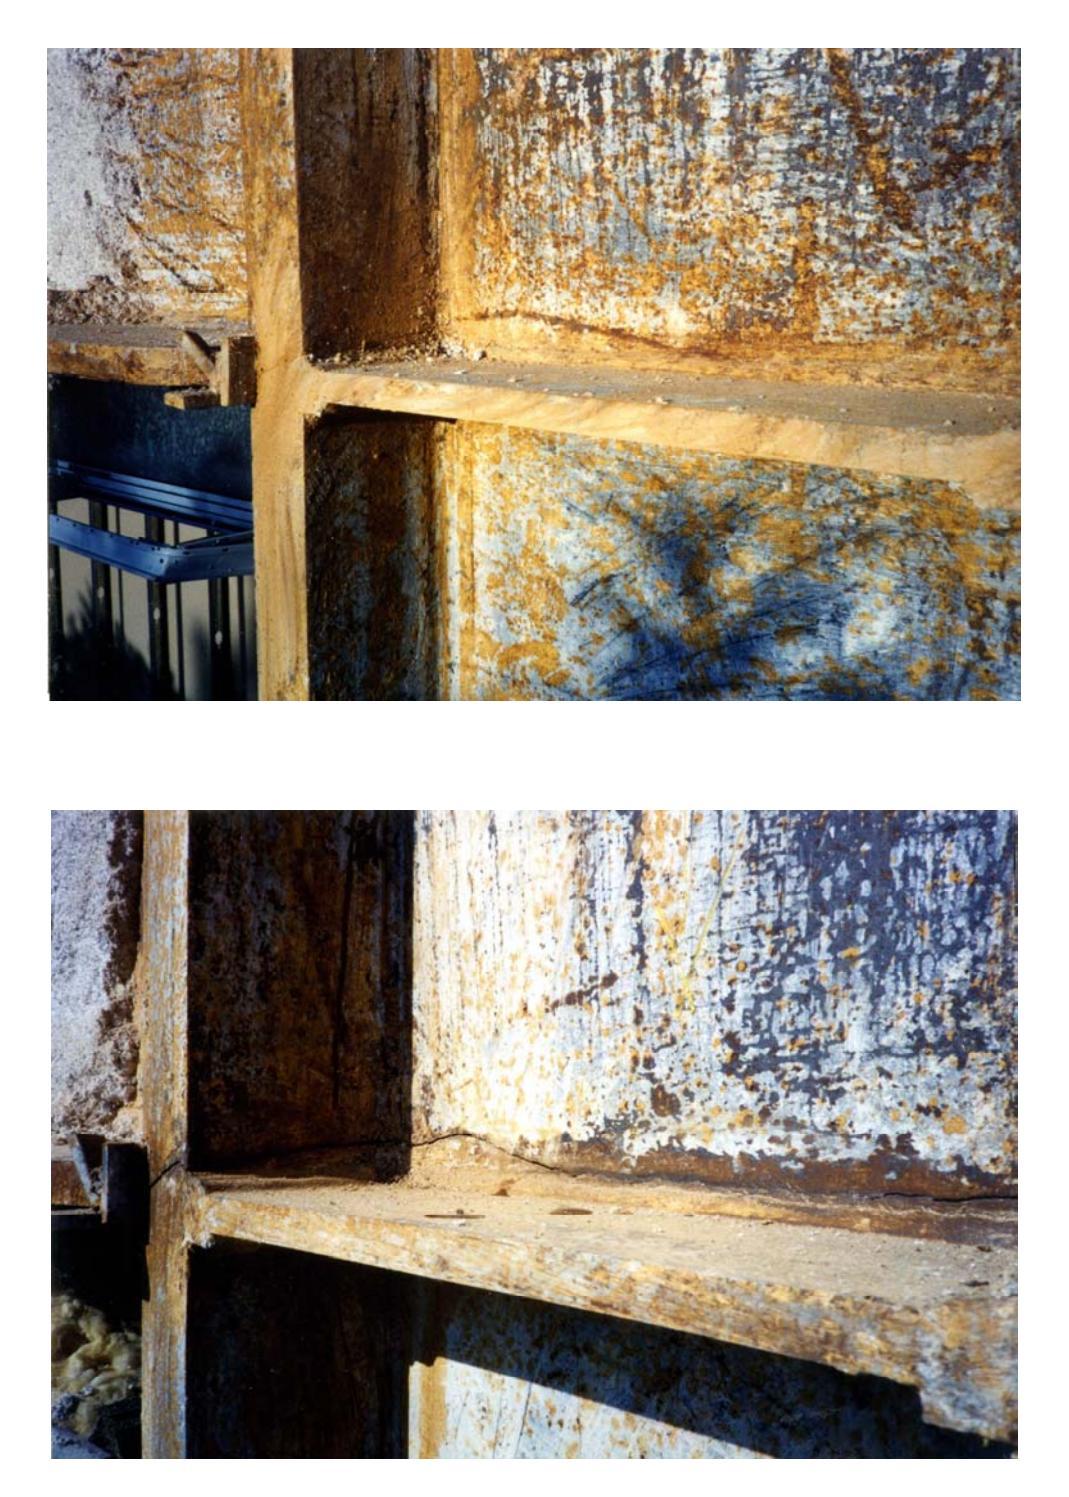
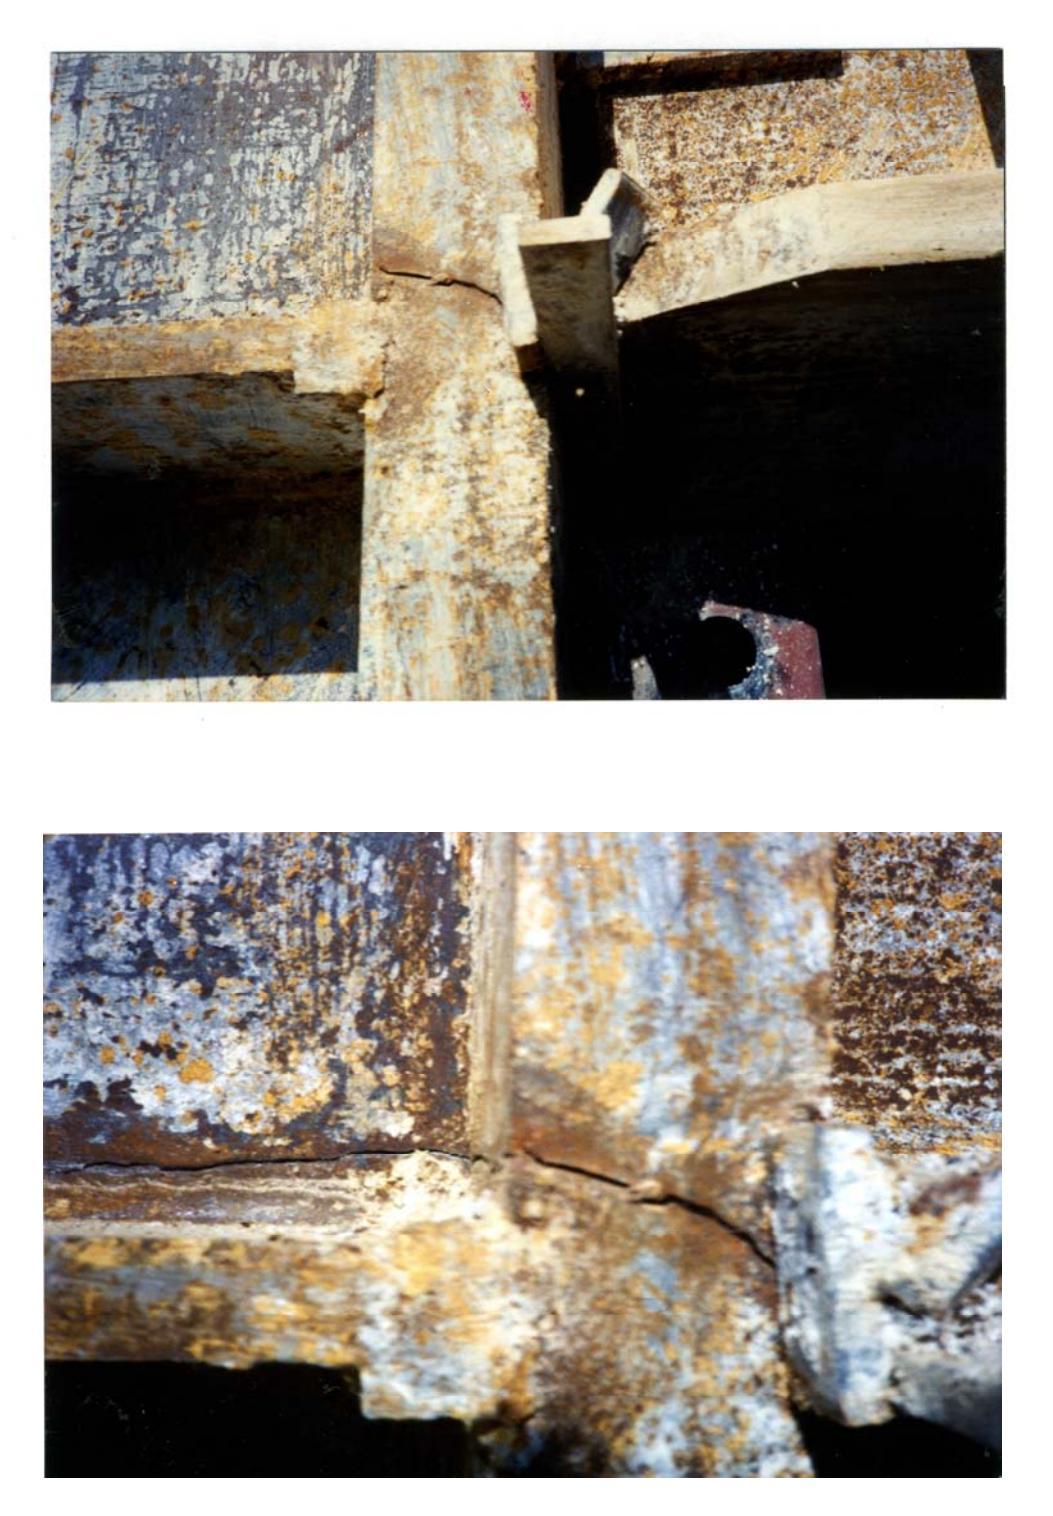
Appearance of the cracks which in most cases started from the weld at the bottom flange of the beam and on some occasions propagated into the column flange or even column web (as in the case of the two-story building discussed later in this document in which cracks expanded all the way through the column web), undermined the confidence in the ductile behavior of the steel moment frames [37]. According to a report by Youssef et al. in 1995, brittle fracture in and around the groove weld connecting the beam flanges to the column flange was observed in more than 150 steel moment frame buildings after the Northridge Earthquake [37].

Photos shown in Figure 3.7 clearly illustrate the initiation of the crack from the weld area and its propagation into the column flange and eventually the column web.

Figure 3.7: Damage observed in the two-story building after the Northridge Earthquake (Photos courtesy of Peter J. Maranian).

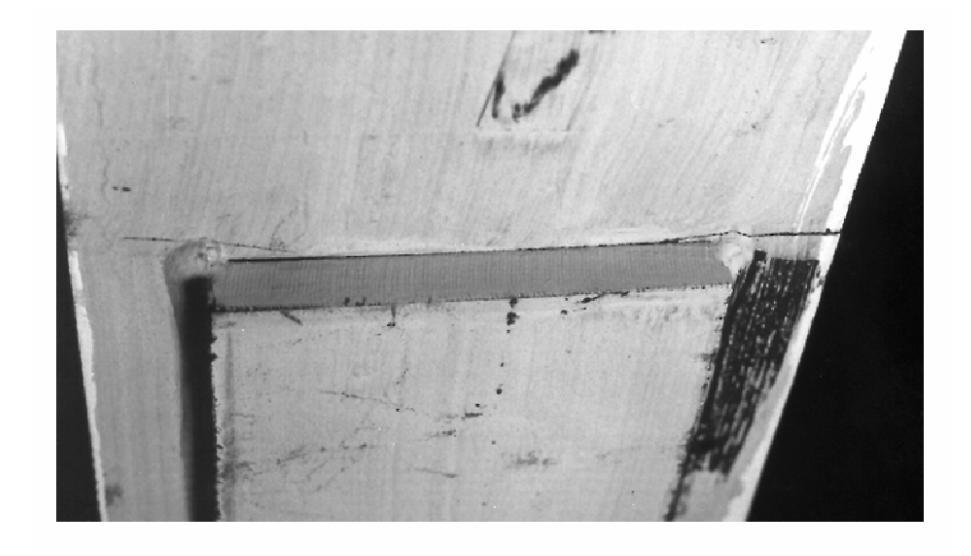
Figure 5.3: Fatigue crack at the end of cover plate fillet weld toe. [23]

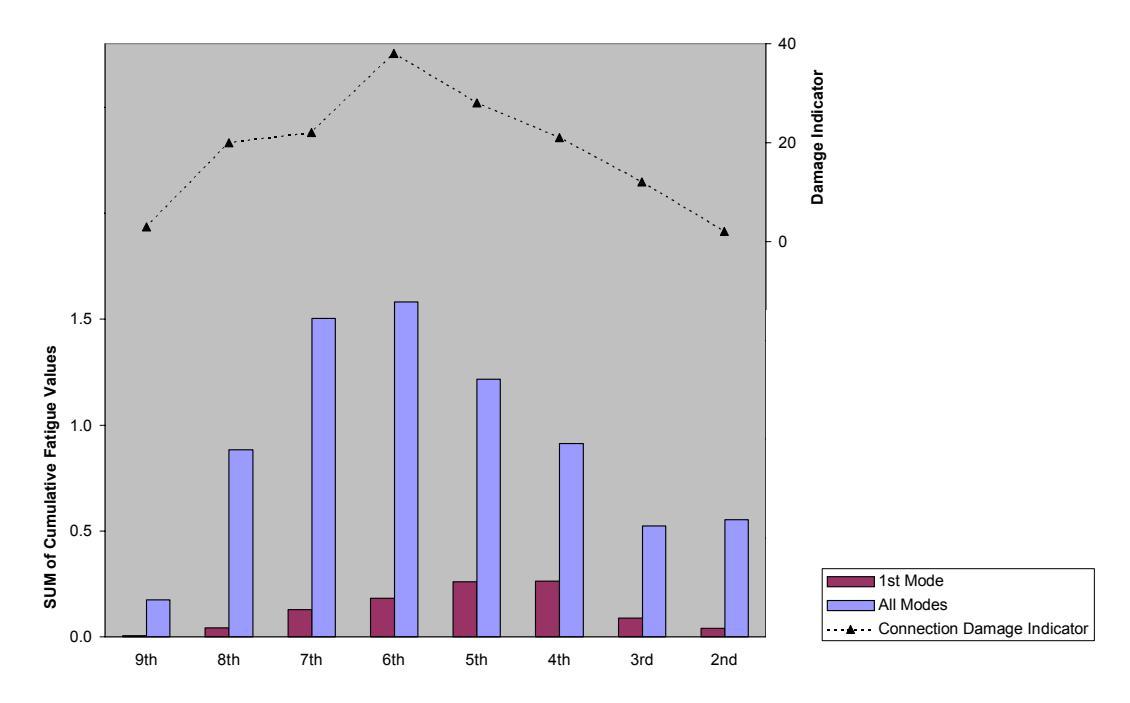
Figure 6.1: Comparison between cumulative fatigue distribution and observed damage in the ten-story building.
