## THE EFFECT OF HIGHER MODES ON EARTHQUAKE FATIGUE DAMAGE TO STEEL MOMENT FRAMES

A Dissertation Presented to the FACULTY OF THE GRADUATE SCHOOL UNIVERSITY OF SOUTHERN CALIFORNIA In Partial Fulfillment of the Requirements for the Degree DOCTOR OF PHILOSOPHY (CIVIL ENGINEERING)

May 2008

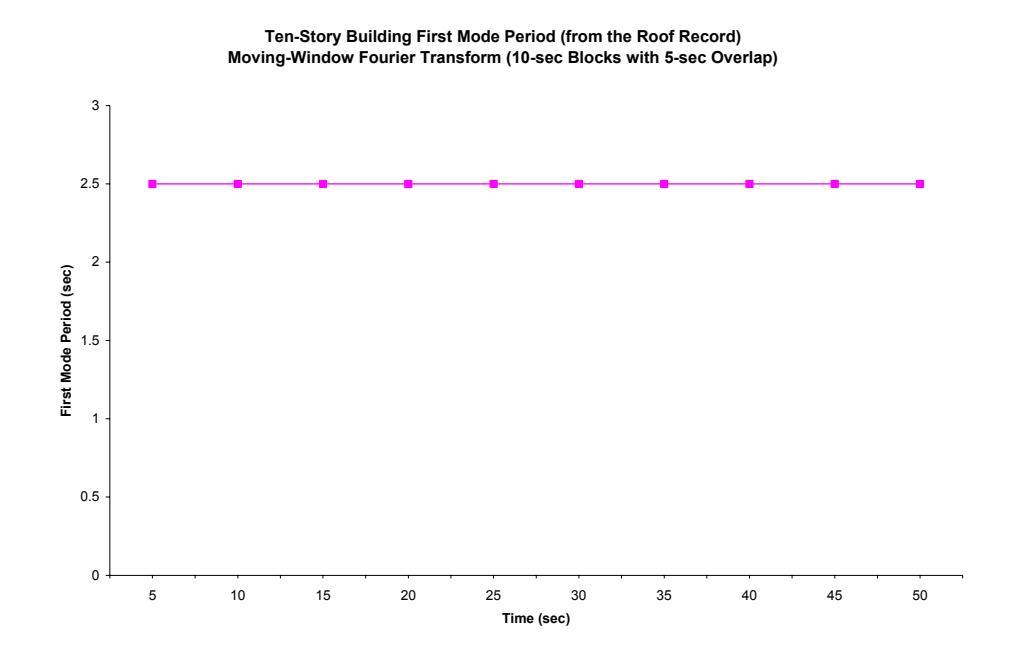
Figure 4.32: Moving-window Fourier transform of the CDMG roof acceleration record.

As indicated earlier in this chapter, the CDMG record at the roof of the building was available for this study. Result of a moving-window Fourier transform of the CDMG roof acceleration record has been shown on figure 4.32. The moving window analysis has been performed in MATLAB [www.mathworks.com]. For this analysis, ten-second blocks with 5-second overlaps have been used. The results indicate that the first mode period of the building is 2.5 seconds. This result shows good compatibility with the first mode period of the building did not change during the Northridge event. This means that there have not been significant nonlinearities in the building.

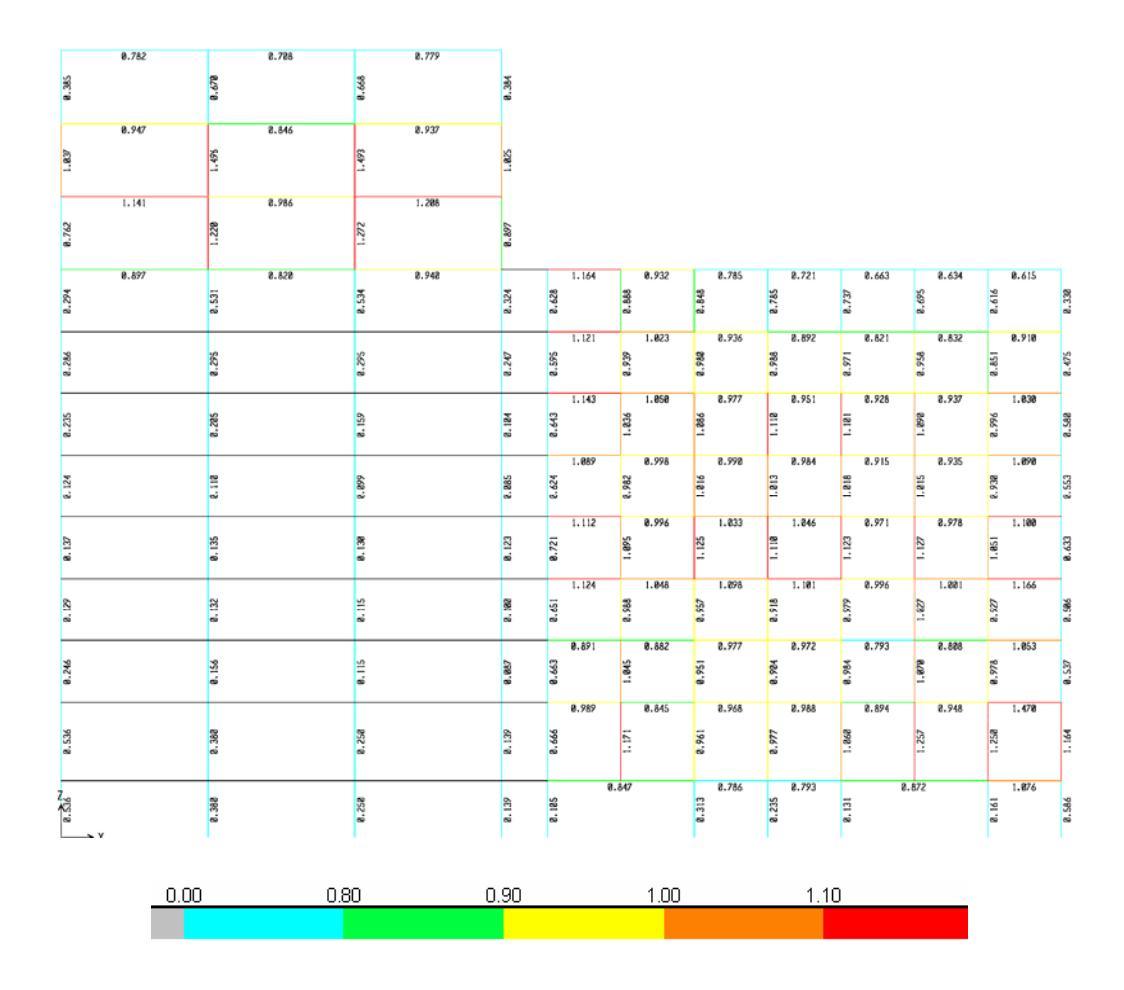
Figure 4.35: Demand to capacity ratios in the ten-story building result of linear modal time-history analysis using SAP 2000.

This observation is well justified by studying the maximum stresses (M/S) at the investigated beams and columns. This study has been performed on maximum stresses resulting from the linear modal time-history analysis. As shown in figures 4.33 and 4.34, the maximum stresses are not significantly larger than the yield value. This combined with the fact that higher than yield stresses happened in very few cycles (figures 4.19 and 4.23), give more validity to the linear modal time history analysis. As a result, building nonlinearities have not been significant during the Northridge Earthquake and use of the linear modal time-history analysis is adequate for the purposes of this study. Low demand to capacity ratios as shown in figure 4.35 indicate that response is mainly linear-elastic and confirms the previous observations.

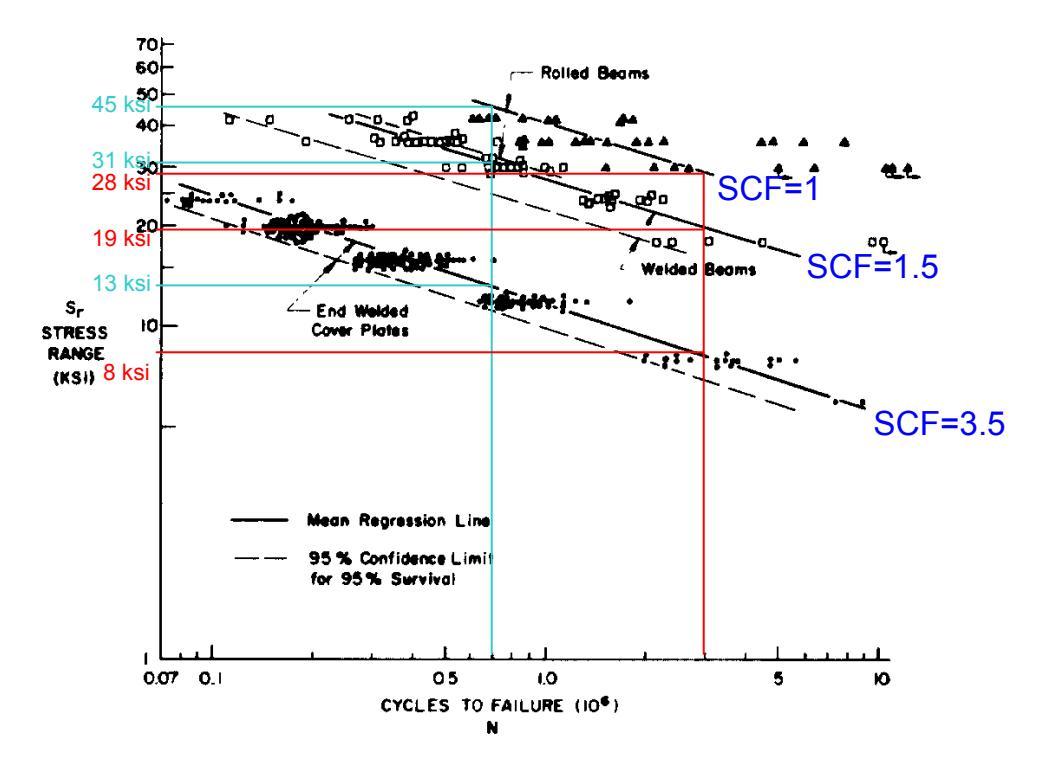
Figure 5.9: Stress concentration factors observed in Fisher's tests.

In the high-cycle region, tests by Fisher et al. indicate that SCF associated with *welded beams* and *beams with end welded cover plates* are respectively 1.5 and 3.5 relative to *rolled beams*. Figure 5.9 shows how these values are estimated.

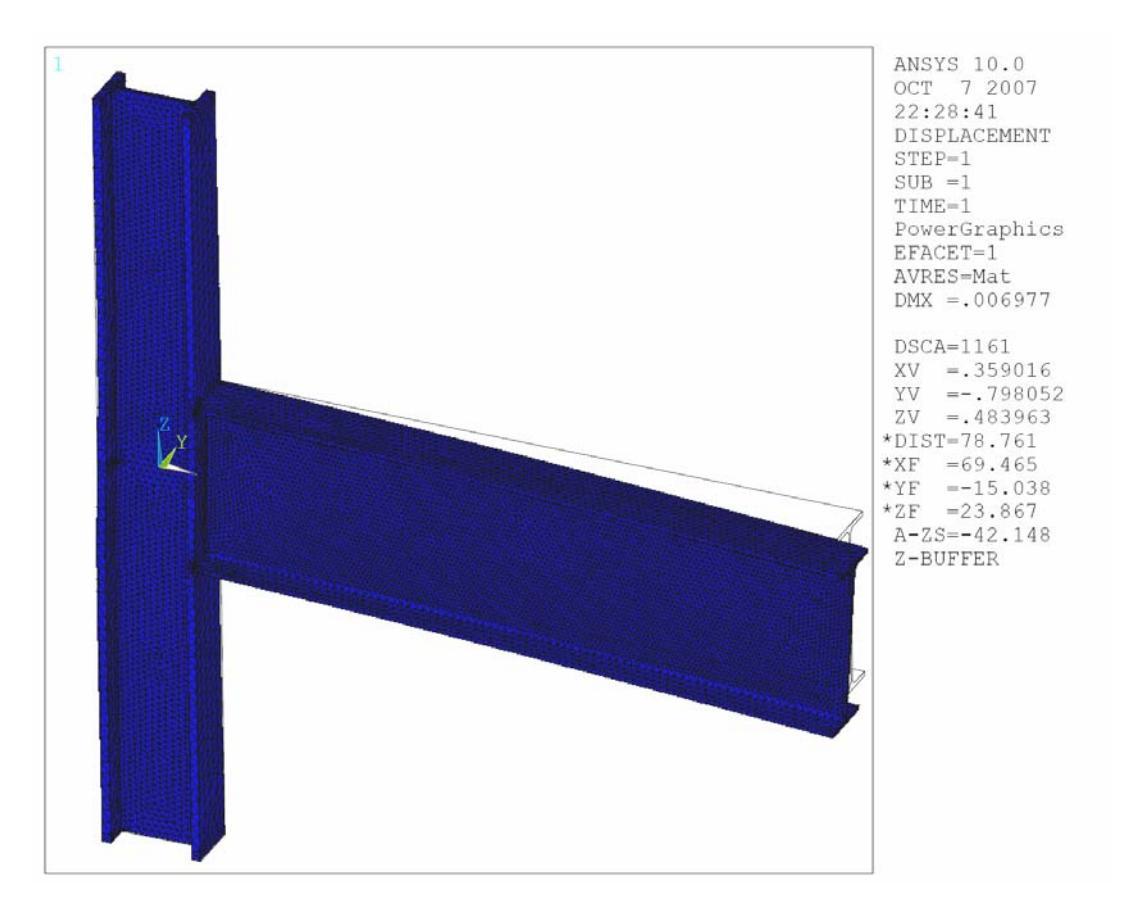
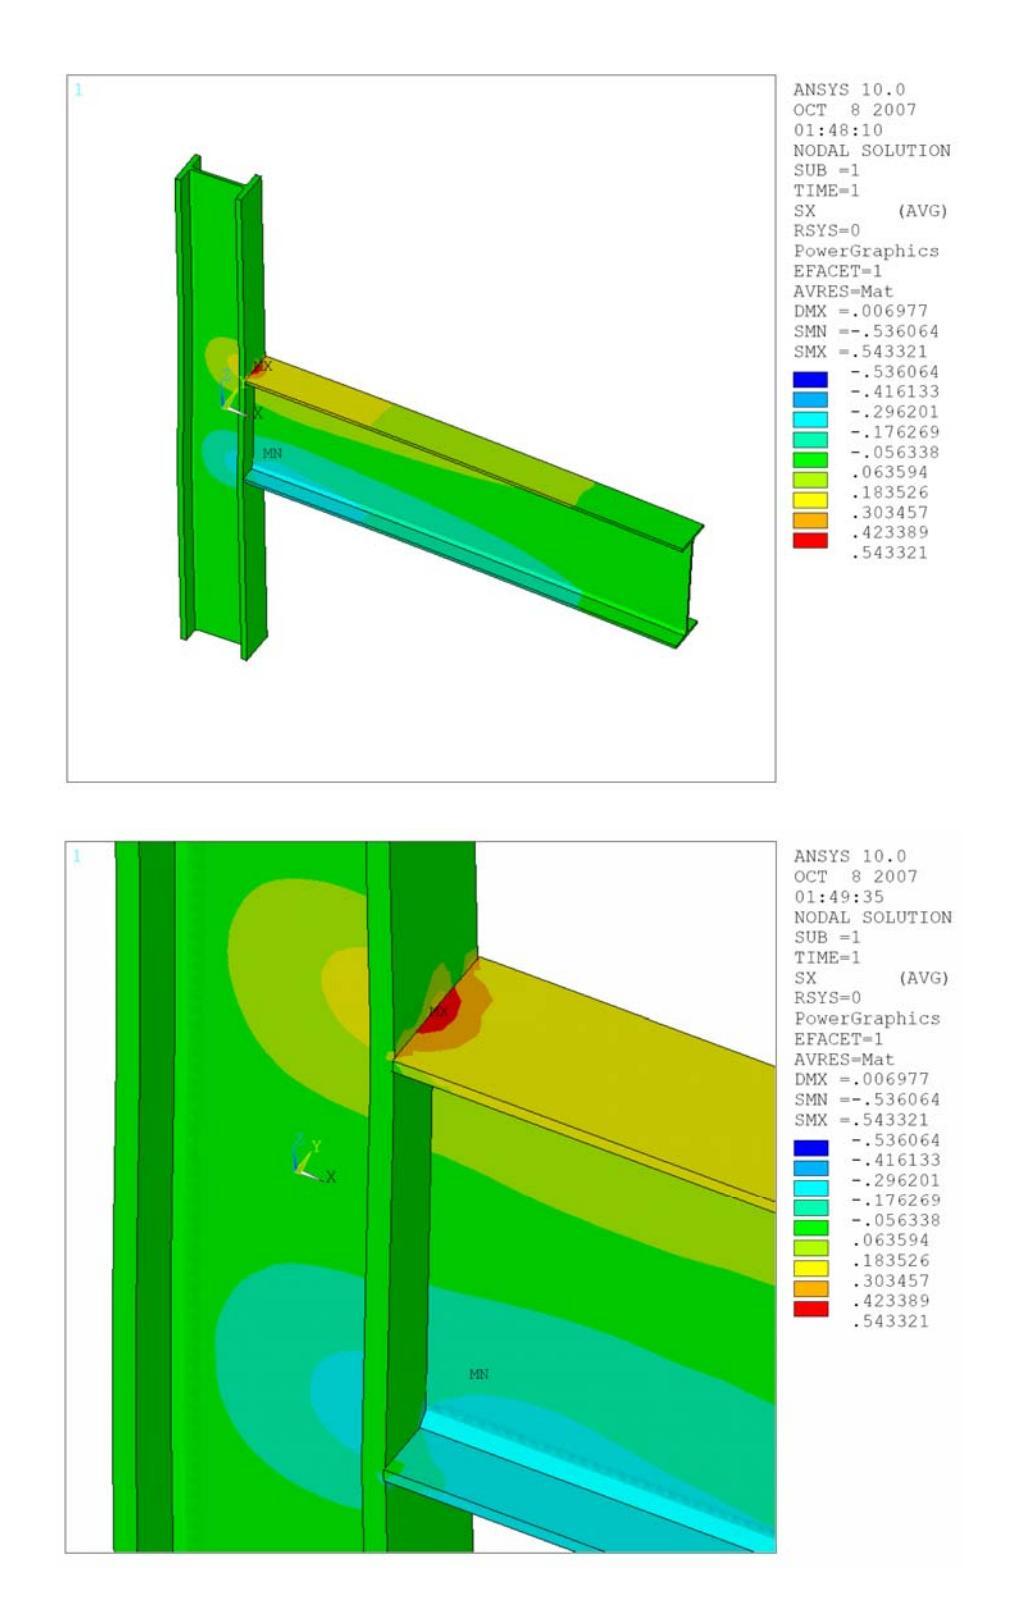
Figure 5.11: Result of the finite element study of the model without continuity plates.

Figure 5.10 shows the finite element model of the connection without continuity plates and figure 5.11 shows the result of the analysis. This study indicates that the SCF is 1.92 for the Pre-Northridge connection without continuity plates. This SCF is calculated as the ratio of maximum stress observed as the result of the finite element analysis to the maximum bending stress in the beam (M/S).

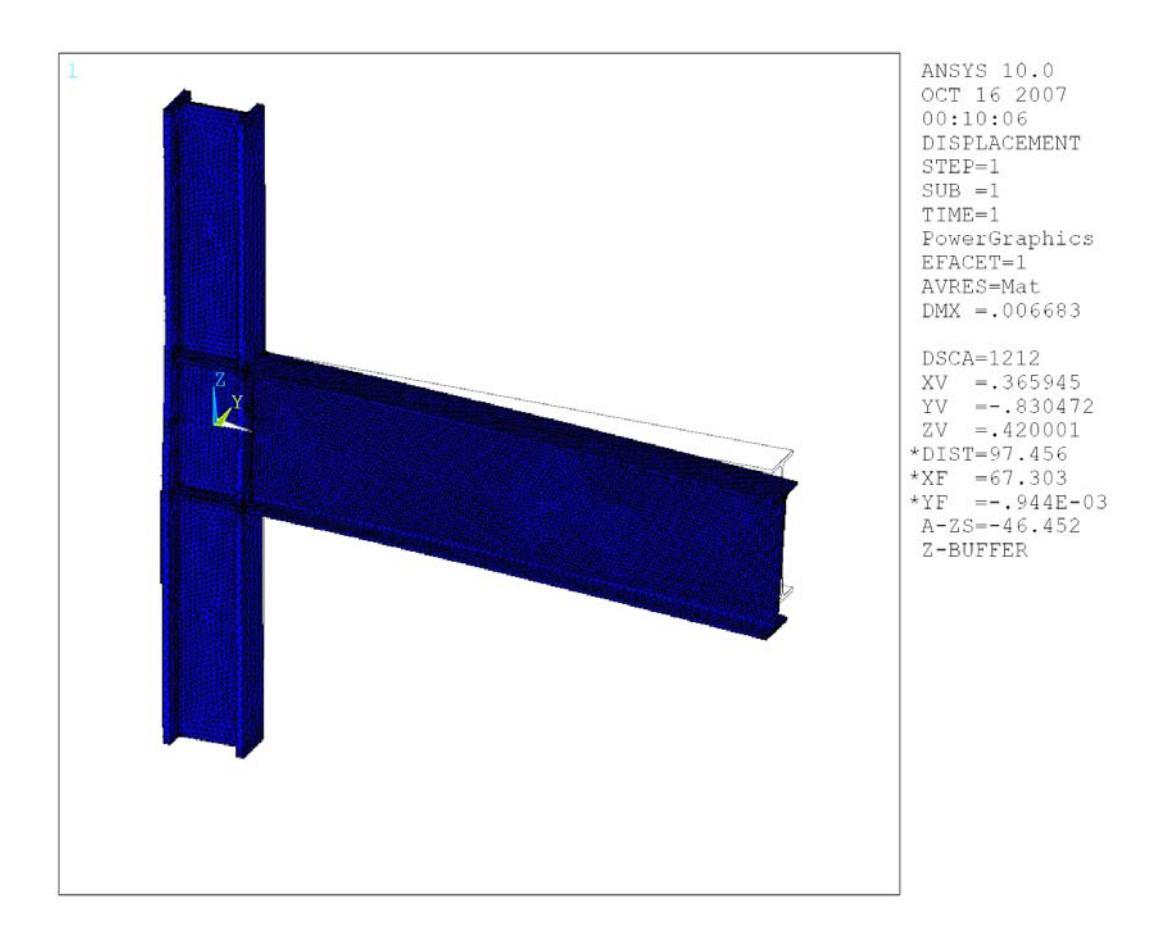
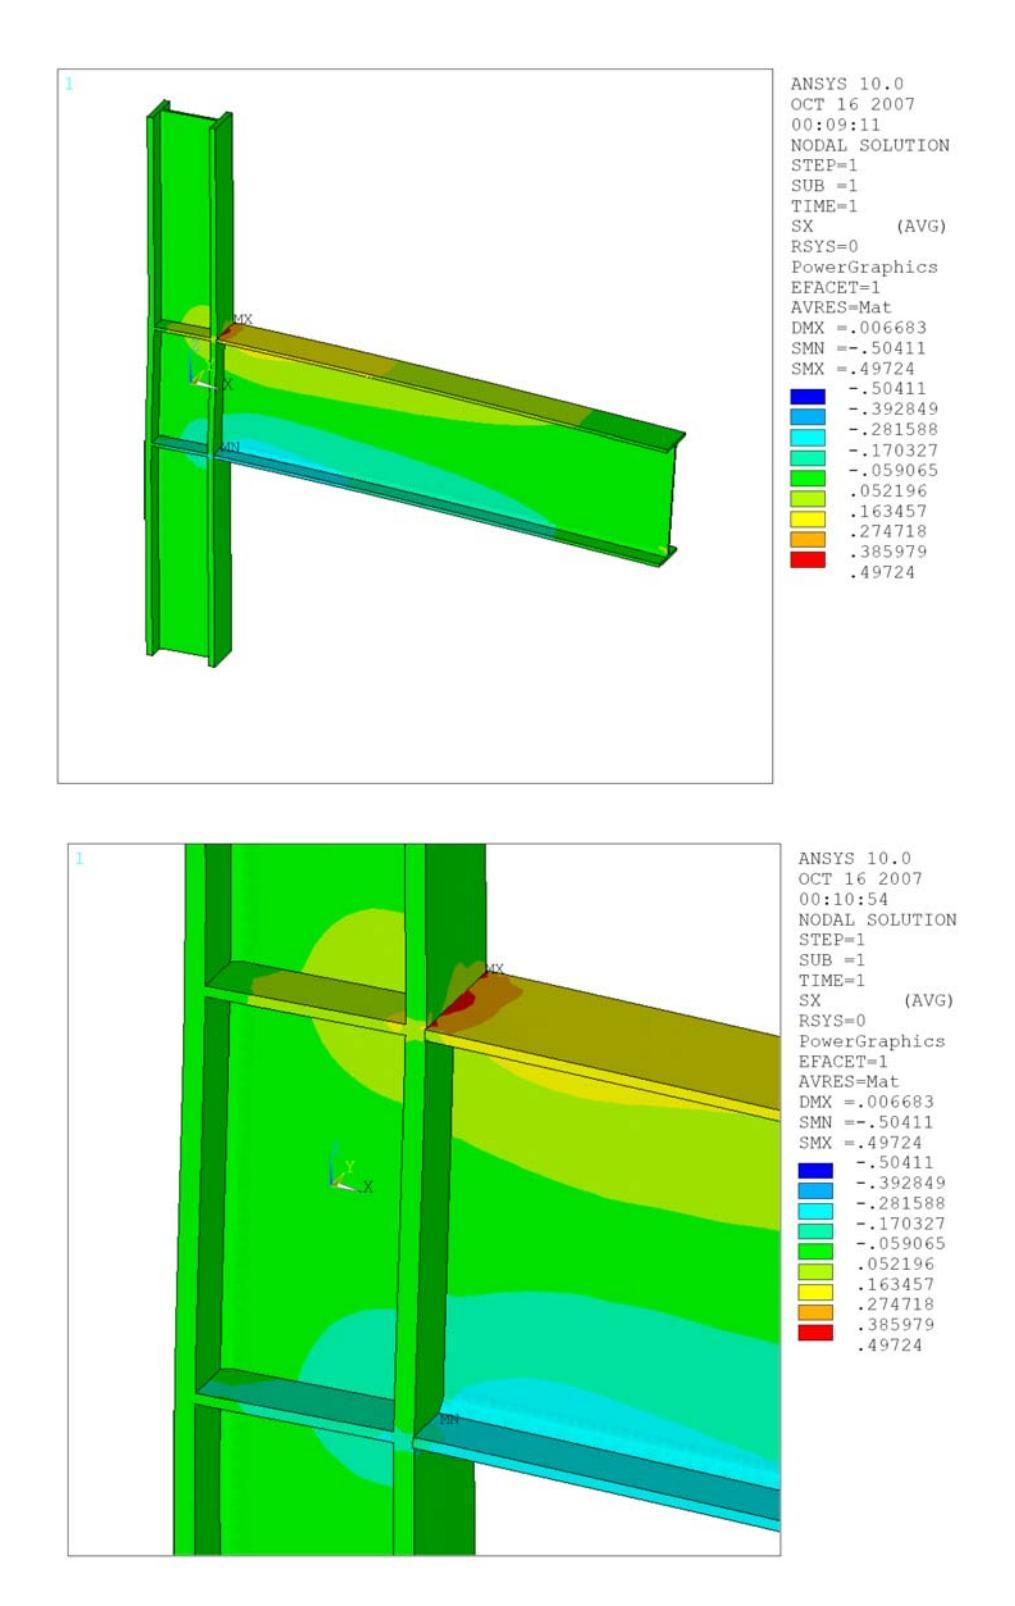
Figure 5.13: Result of the finite element study of the model with continuity plates.

Figure 5.12 shows the finite element model of the connection with continuity plates and figure 5.13 shows the result of the analysis. This study indicates that the SCF is 1.75 for the Pre-Northridge connection with continuity plates. This SCF is calculated as the ratio of maximum stress observed as the result of the finite element analysis to the maximum bending stress in the beam (M/S).
